### MULTIPLE COAT FAILURE

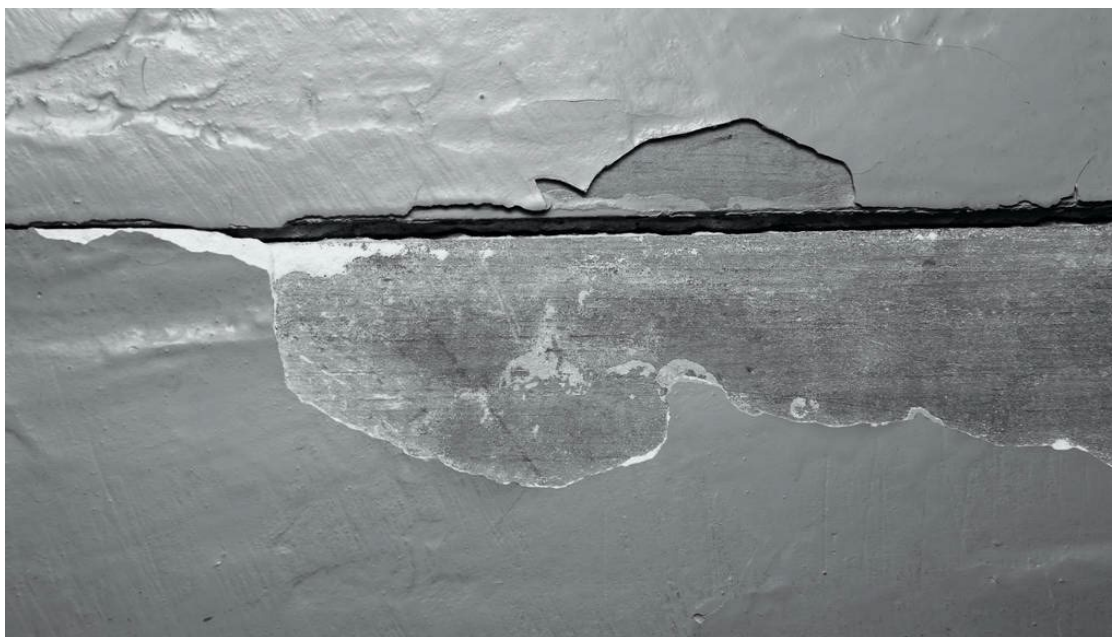
Figure 1

Multiple coat failure occurs when two or more paint layers detach together from a substrate or from an underlying coat. The topcoat often remains bonded to the layer beneath it, so the failure originates in a previously applied coat—or, in more severe cases, at the original substrate (Figure 1).

- **Excessive paint buildup:** Thick, multi-layer paint systems increase internal stress. Older, brittle coats often can't accommodate normal substrate movement, so repeated expansion and contraction can cause separation at the weakest interface. Heavy film build can also add weight, increasing mechanical stress on the underlying bond line. Oil-based paint in underlying layers: This issue is often worse when a water-based coating is applied over a previous coat (or intermediate layer) that is oil-based. Oil-based paints cure by oxidation and become less flexible as they age, especially if they were left exposed for extended periods before repainting.

- **Poor surface preparation of previous coats:** Dirt, chalk, mildew, grease, or glossy surfaces reduce adhesion. Even when initial adhesion appears acceptable, marginally prepared layers can fail later after additional coats are applied. The underside of peeled paint often shows evidence of the original surface contamination.

- **Moisture intrusion:** Moisture trapped behind the paint film forces layers away from the substrate. Sources include surface cracks, leaks, faulty flashing, and unsealed joints. Staining or discoloration on the underside of peeled paint often points to moisture as a contributing factor.
- **Application of dark colors:** Dark finishes absorb more solar heat, raising surface temperature and increasing thermal cycling. When paired with heavy film build and borderline adhesion, dark colors can intensify stress on underlying layers and speed up delamination.

1. Address moisture first by repairing leaks, gutters, flashing, and seal joints; improve ventilation to reduce condensation.
2. Scrape or strip all loose, flaking, or poorly adhered layers back to a sound substrate. Do not simply paint over marginally adhered coatings.
3. Scuff sand glossy or slick areas to create mechanical tooth; use abrasive blasting or chemical stripping where appropriate for metal and masonry.
4. Remove mildew, dirt, chalk and other foreign contaminants with an appropriate cleaner, rinse, and allow complete drying.
5. Spot-prime bare surfaces with the correct primer for the substrate.
6. Observe manufacturer recommendations for temperature, humidity, recoat intervals, and color selection to avoid application-related stress.
