EFFLORESCENCE

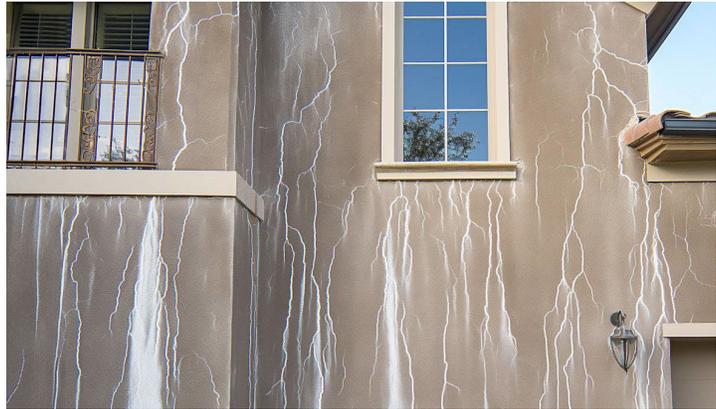
Figure 1

Efflorescence is a common condition that can appear on cement-based surfaces such as stucco, masonry, and concrete. It shows up as a white, crystalline residue on the surface (Figure 1). While it can be visually concerning, efflorescence is usually a cosmetic issue, not a coating failure. Understanding how and why it occurs helps set proper expectations and guides appropriate coating selection and application practices.

Efflorescence occurs when water moves through a cement-based substrate, dissolves naturally occurring salts within the material, and carries them to the surface. As the water evaporates, the salts are left behind, forming the visible white deposit. Efflorescence most commonly appears during cool, damp weather followed by drying conditions, often shortly after construction or coating application, particularly in spring or fall.
